Report Number: 214-TRC-06-005

Safety Compliance Testing For FMVSS 214

Side Impact Protection

**Hyundai Motor Company
2007 Hyundai Elantra 4-door sedan**

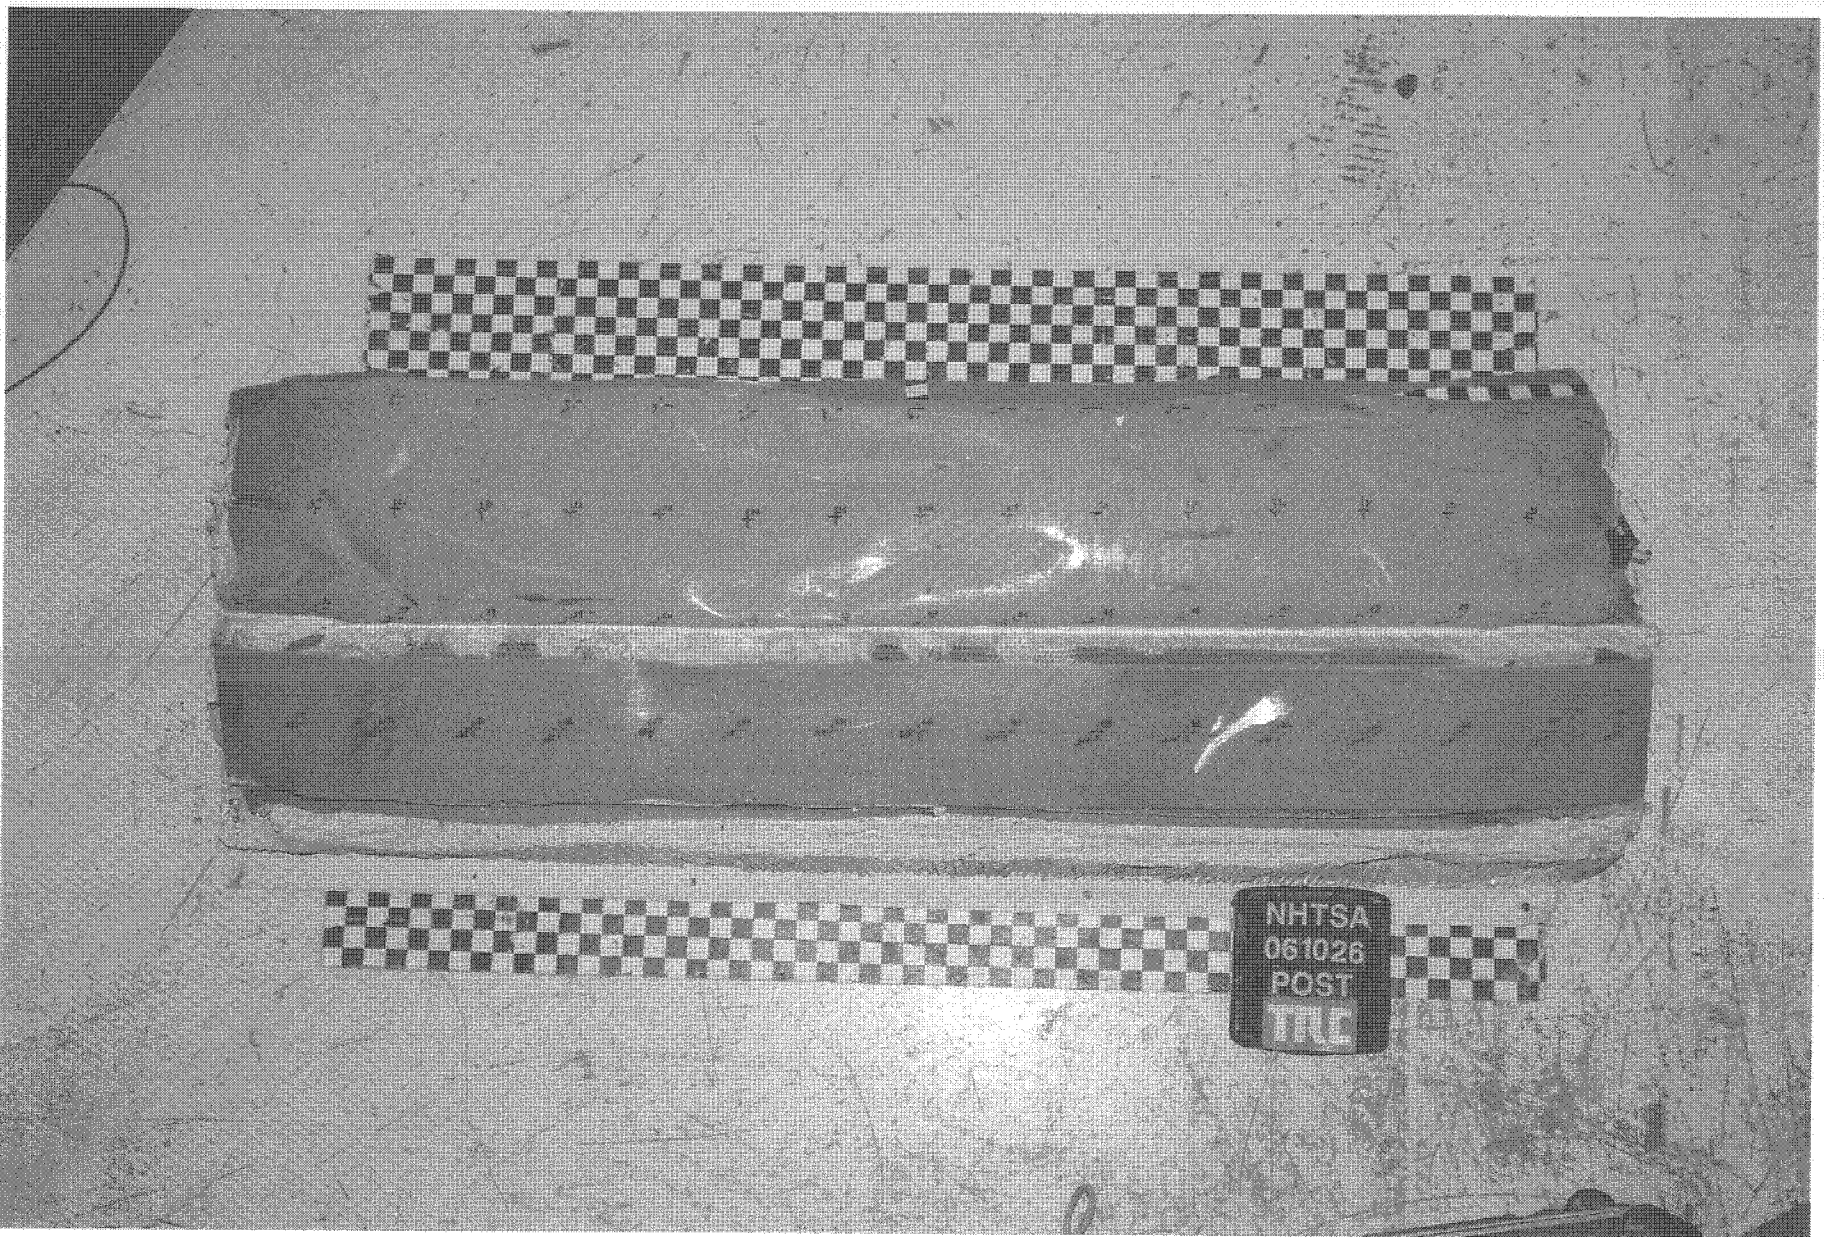
Figure A-17 Post-Test Frontal View of Impactor Face

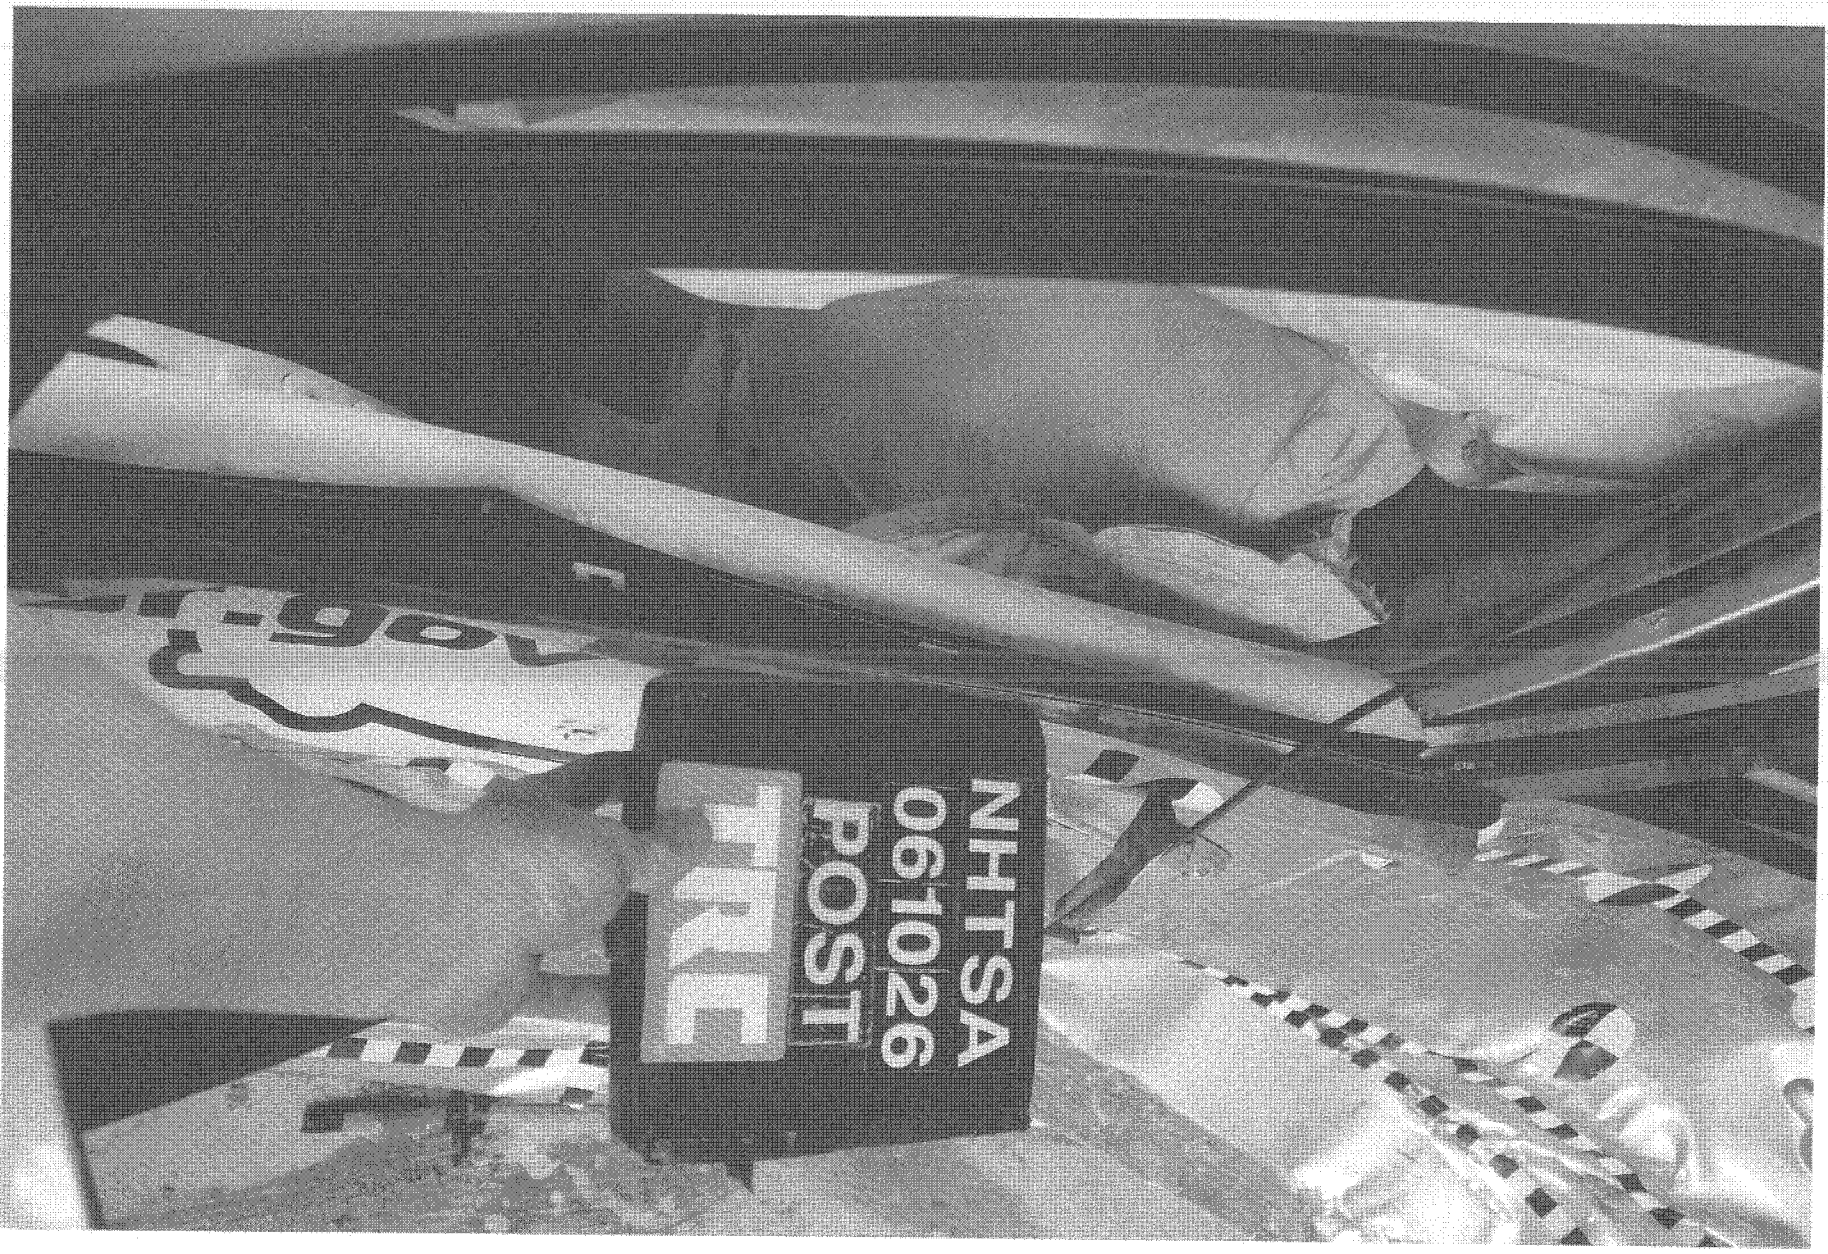
Figure A-45 Post-Test Left View of Front SID HII and Door Clearance

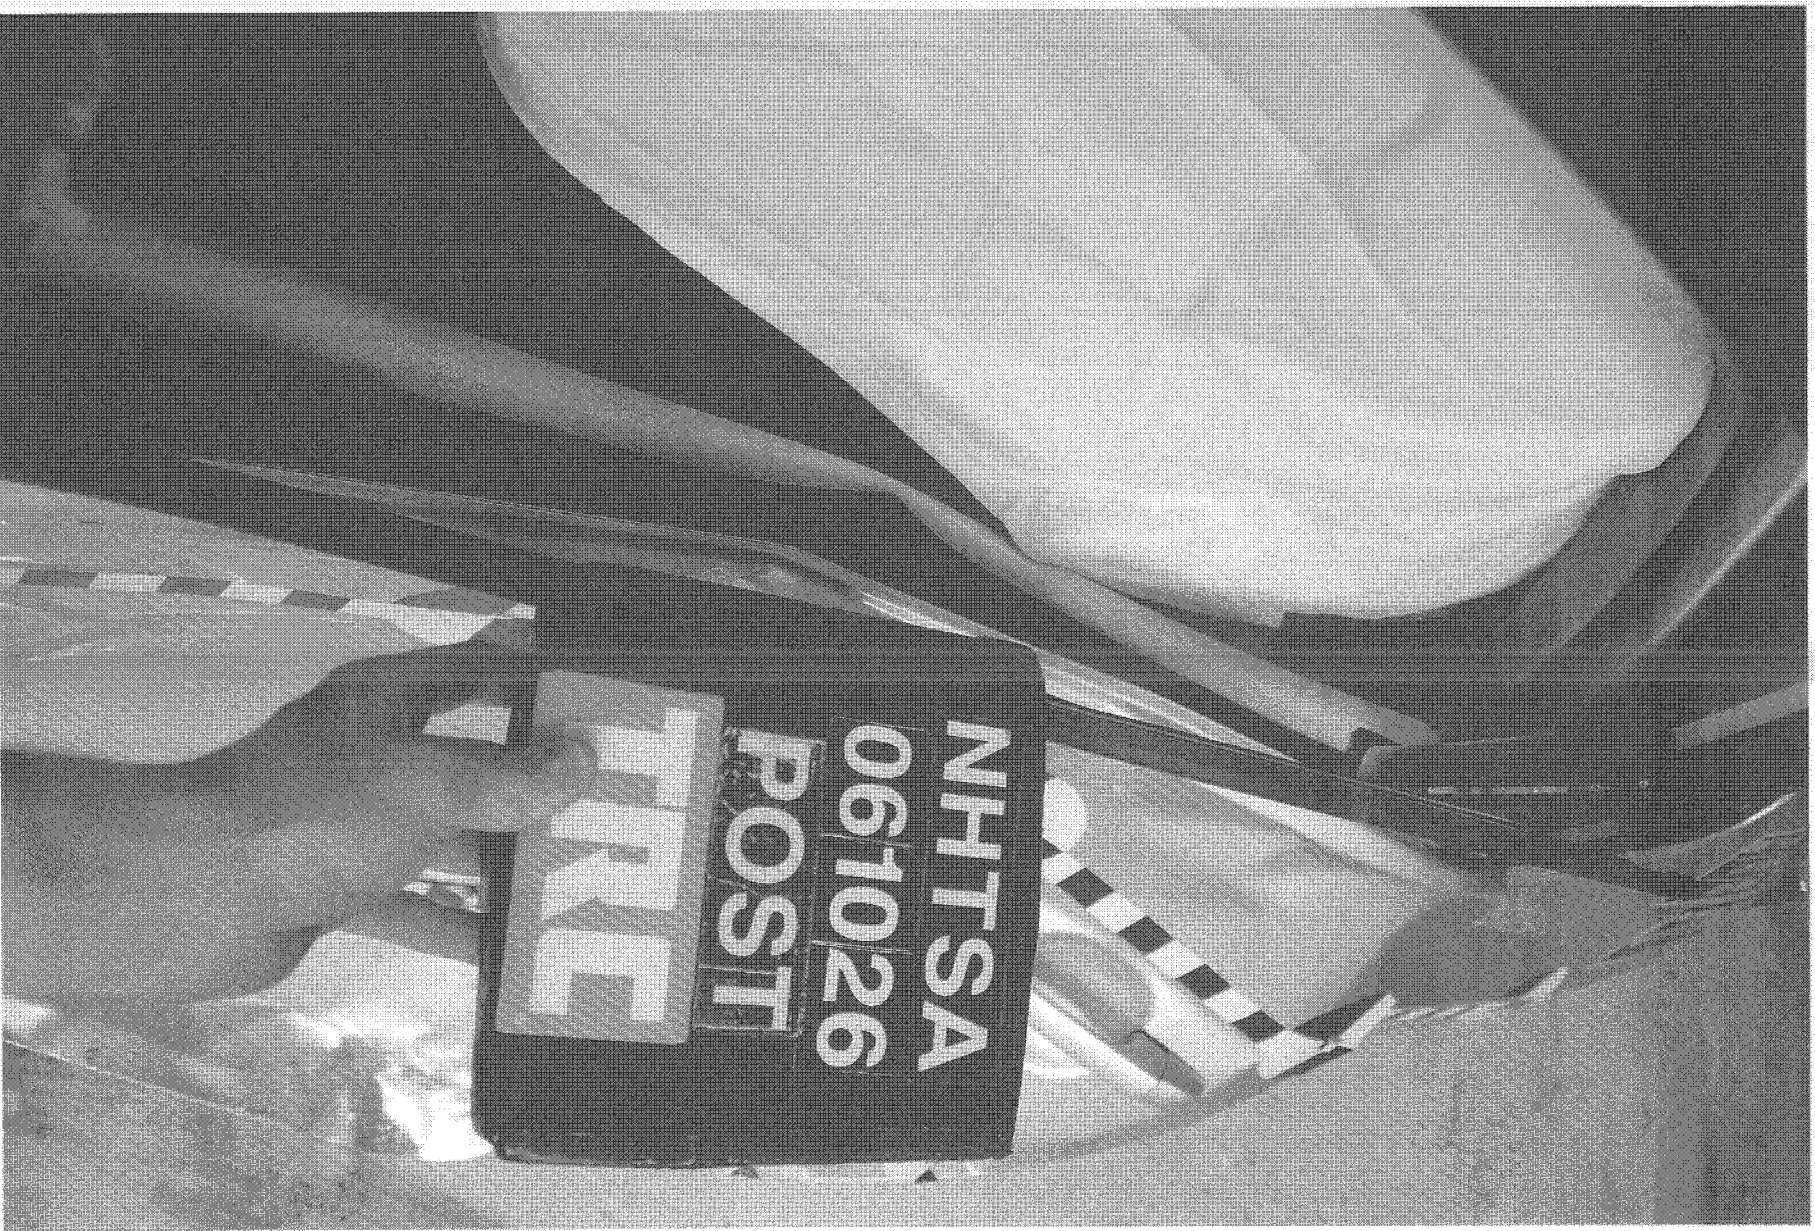
Figure A-50 Post-Test Left View of Rear SID Hill and Door Clearance

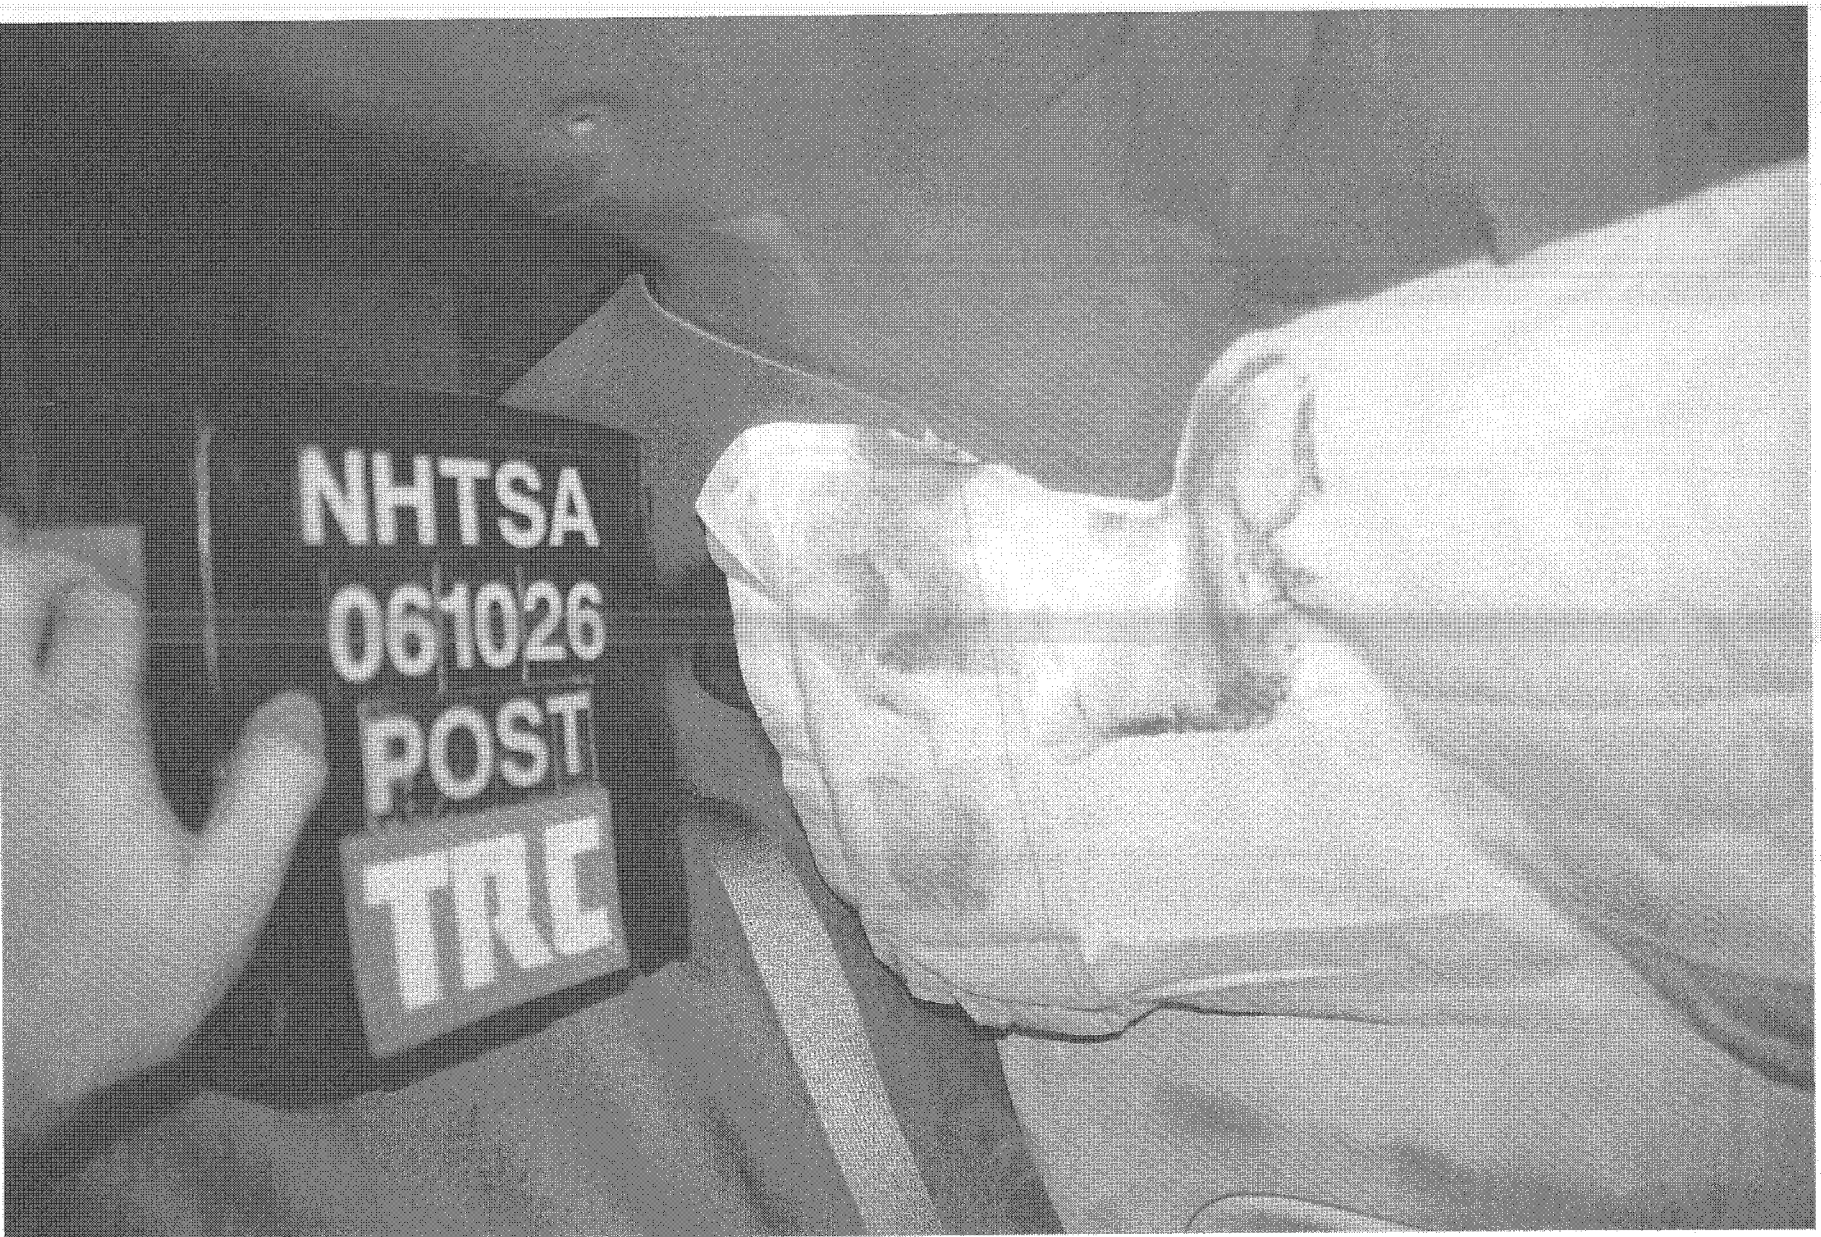
Figure A-57 Post-Test Rear SID HII Contact - View 1

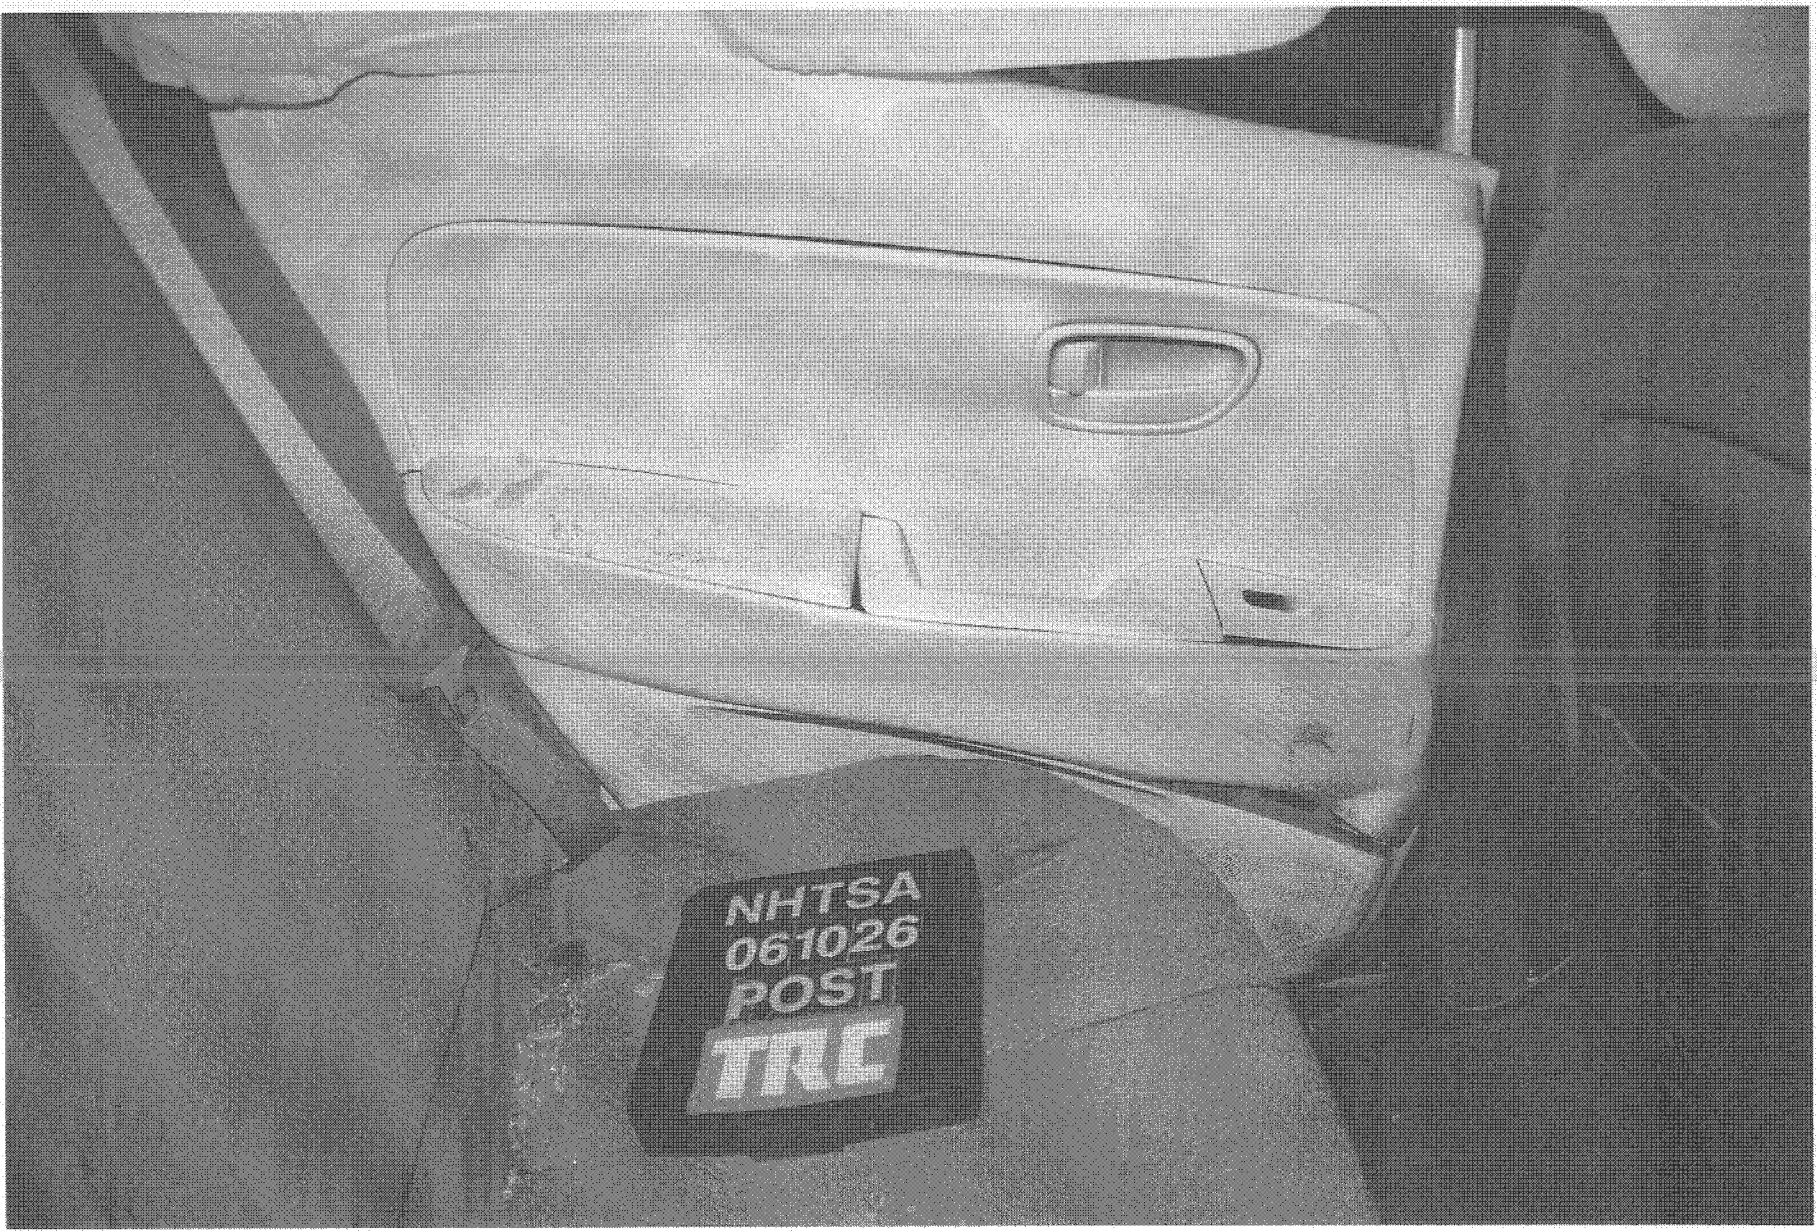
Figure A-58 Post-Test Rear SID Hill Contact - View 2

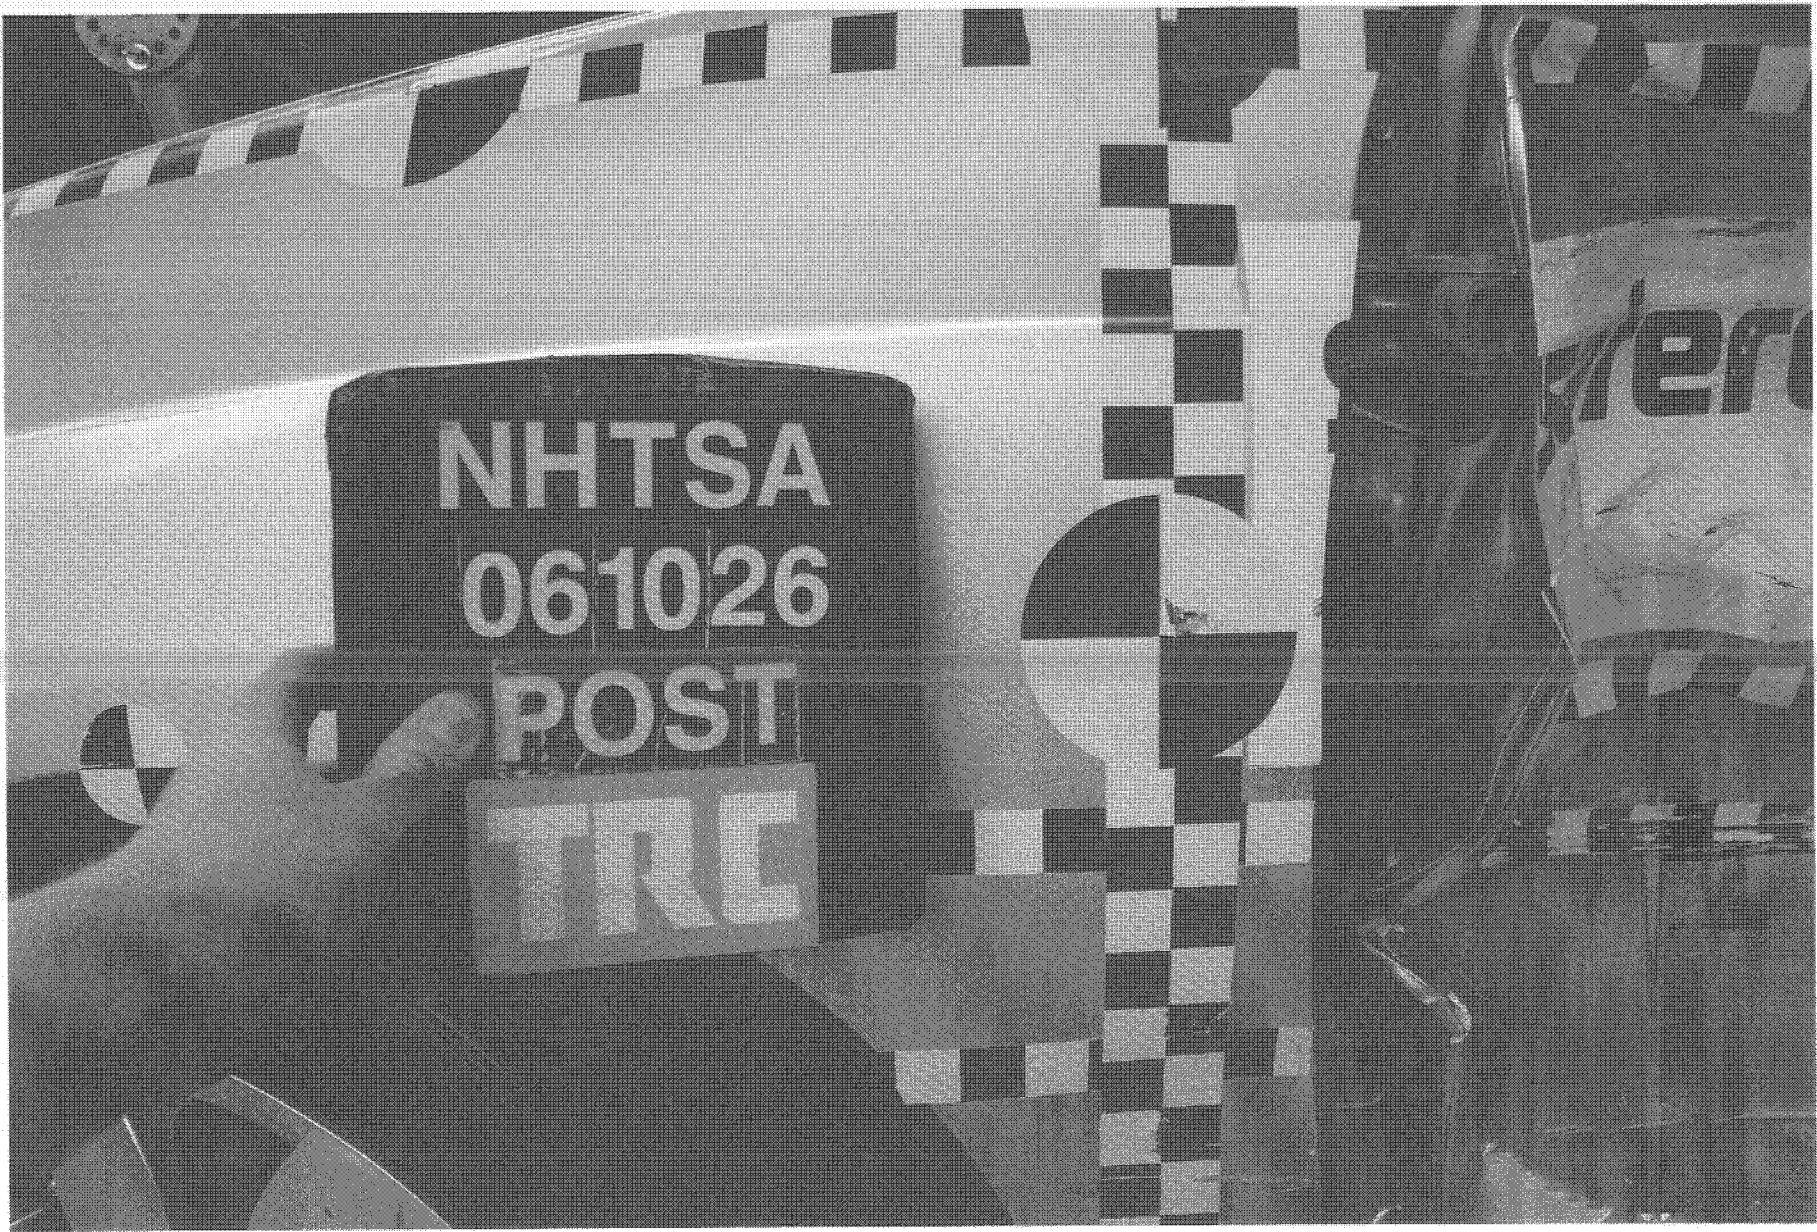
Figure A-62 Post-Test Primary Impact Point View

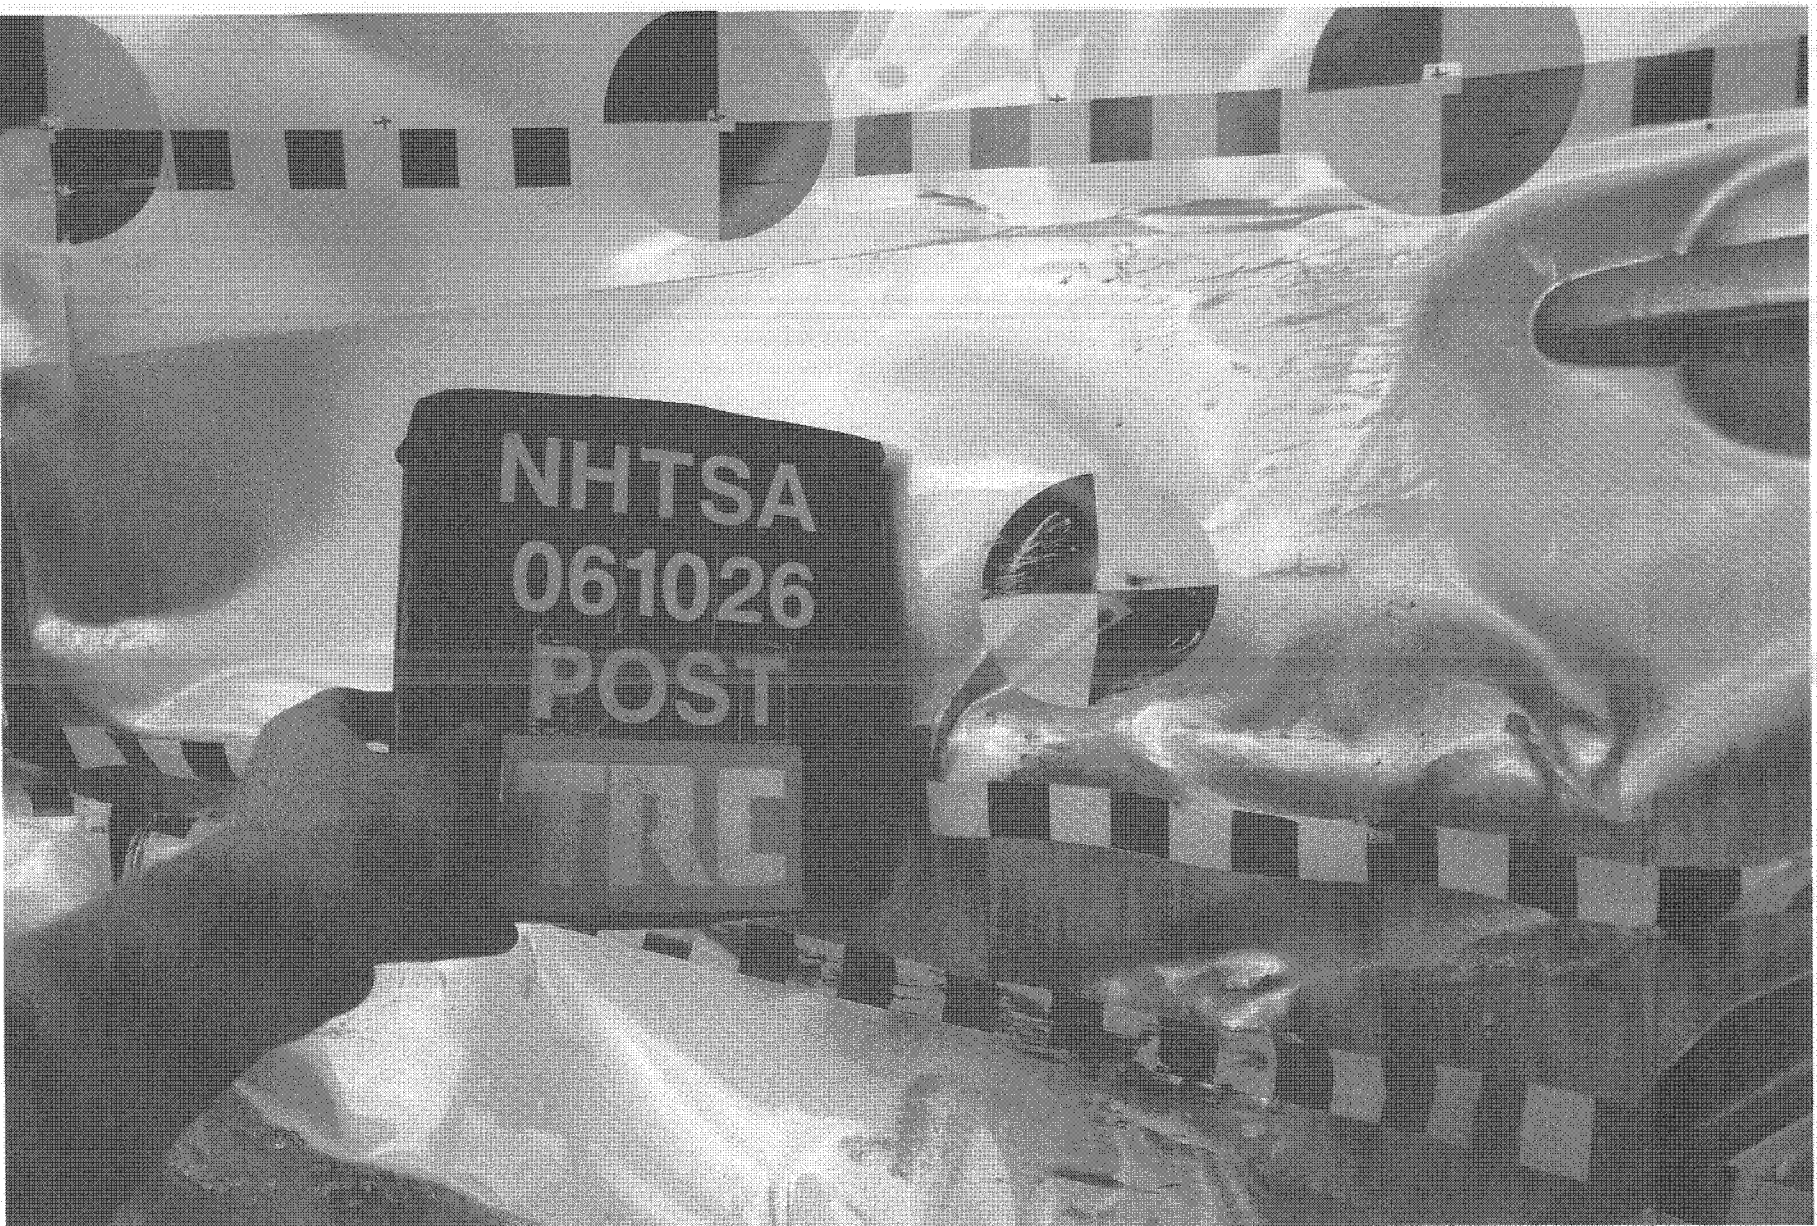
Figure A-66 Post-Test Secondary Impact Point View
